Inspection Report Minerals Regulatory Program April 19, 2011

Mine Name: Organa Claims	Permit Number: S/055/0013		
Operator Name: Organa Minerals Products Inc.	Inspection Date: April 19, 2011		
Inspector(s): Sue Fivecoat BLM, Wayne Western DOGM	Time: 10:45 – 11:10 AM		
Other Participants: none	Mine Status: Active		
Other Participants: none	Mine Status: Active

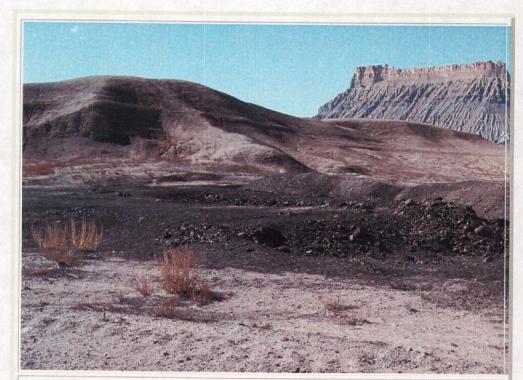
The Operator needs to reclaim the test area on the west side of the road. The Operator did an exploration project on the west side of the road. The BLM said that the Operator was supposed to reclaim the area at the end of 2010. The exploration site is located at an unimproved campsite. Due to multiple uses in the area the BLM wants the Operator to reclaim the area if they will not be mining.

Exploration operations

The Division should request that the bond be increased and that the Operator reclaim the exploration.

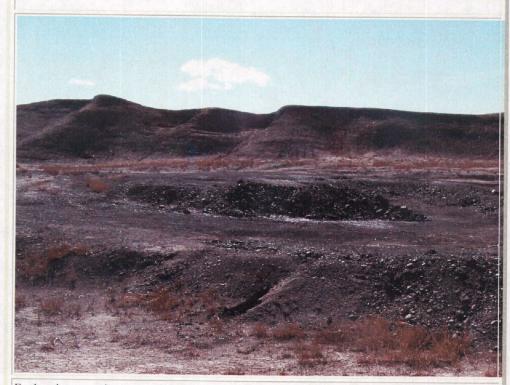
Exploration operations west of road in multiple use area.

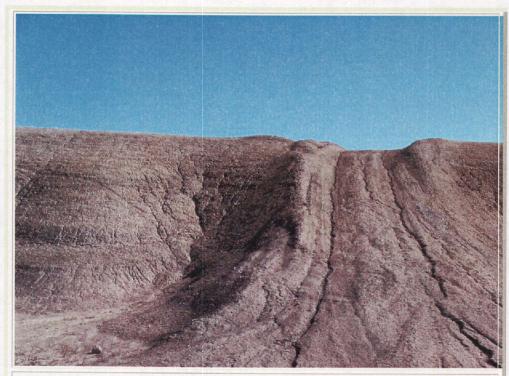
The Operator blazed a new road to the site. See pictures. The site that has been used for production appeared stable.

Access road to eastern operation

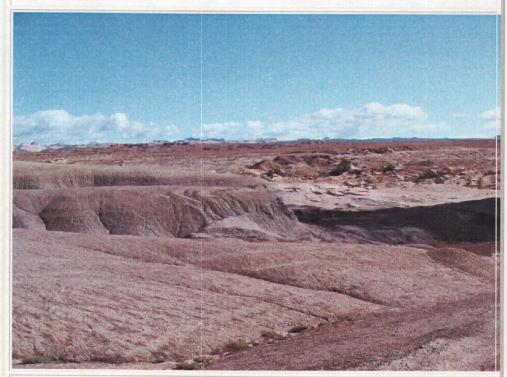
Disturbance on east side of road
